## Analysis of Tapial structures for modern use and conservation

P.A. Jaquin & C.E. Augarde

**ABSTRACT:** Tapial is an ancient form of rammed earth wall construction found in many parts of the world. In medieval Spain, Tapial was used in the construction of some large and complex structures, some many-storied. That these buildings remain standing (many remaining in use) is an indication of the durability of this form of construction, and is perhaps related to the climatic conditions found in central Spain. This paper describes an engineering study into an important structure in the Aragon region, significant parts of which are constructed in medieval Tapial, as well as other forms of construction. The aim of the study is both to improve understanding of the nature of this structure and to provide guidance on methods of preservation and new construction.

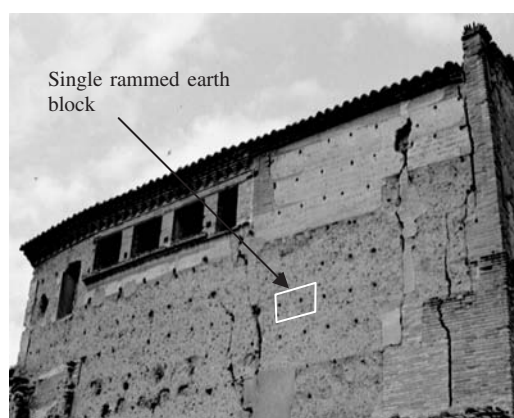
Figure 1. Part of the Preceptory at Ambel.

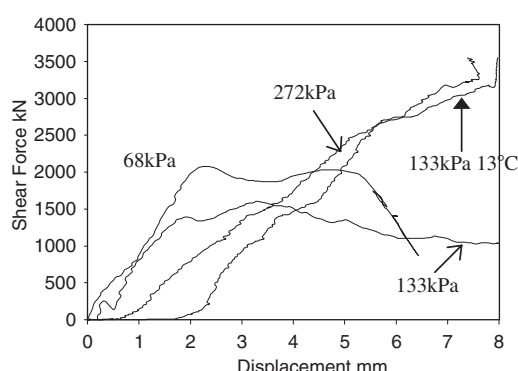
Figure 3. Shear box test results for rammed earth samples.

The results are inconclusive as the plots of shear stress against displacement in Figure 3 shows. Three tests were carried out on samples thought to date from the 19th century and one on a 13th century sample. In the latter samples, a lower peak shear strength is reached in the sample subjected to a higher normal stress, contrary to expectations for standard frictional

materials. For example, predicted angles of friction for the first two samples are  $83^\circ$  and  $72^\circ$  indicating bonding to be significant. The 19th century sample at the highest normal stress, however, does not show a peak strength within the range of testing carried out. The 13th century sample also fails to show a peak strength.

These limited set of tests show that rammed earth is clearly not a simple frictional material but could be regarded as a frictional bonded soil. Clearly a comprehensive sampling and testing programme is required to confirm properties of this material that can be used reliably.

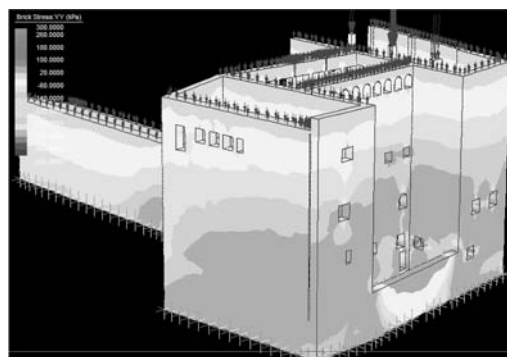
Figure 4. FE model of the building with vertical normal stress contouring.

As an example of the FE modelling, Figure 4 shows the outline of the finite element model used with vertical stresses due to roof loading only and gravity. The stresses range from 0.3 MPa to  $-0.5$  MPa with tension positive. It can be seen that the stresses generally increase down the building, due to the high self-weight of the walls.

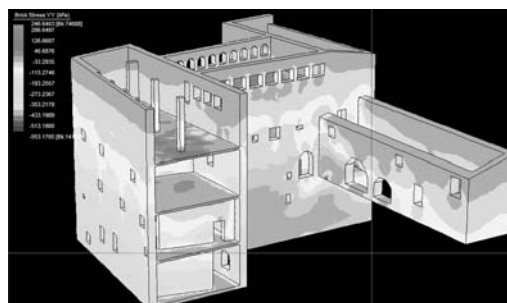
Figure 5. FE model view of the rear of the building.

Figure 5 shows the building from the south, and detailed inspection reveals raised levels of tensile stress between columns of the windows at the top of the building, and also at the floor area around the rear column in room 302. Although the vertical stresses are plotted, the floor is also carrying substantial stresses in the other two directions. The high stresses at this location are due to the floor acting as a transfer beam, as there is no support below. It can be seen by looking at the original plans that this wall is part of a 13th century tower which has been consumed by the building of the 18th century part (that part below room 303). Undoubtedly some of the effects are caused by the idealisations assumed in the modelling, especially the

introduction of the cut line to the model. On a practical level, however, the model demonstrates that this floor should be checked for cracking and deformation, as the whole column load is being transferred through this floor.

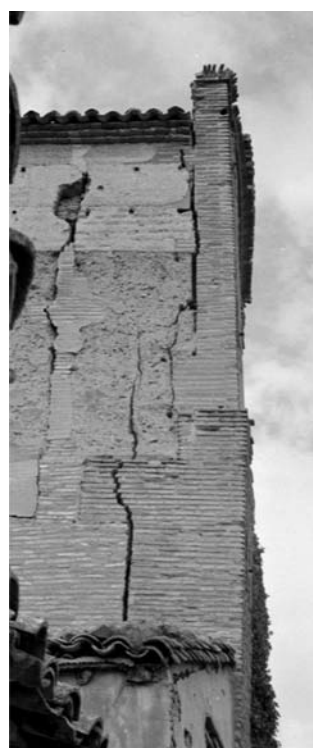
Figure 6 shows the northeast wall of the building where a major crack is visible. This appears to be the worst crack in the building. Externally, the crack runs between the brick quoins which form the corners of the building, but at around 2/3rds height the main crack stops and another crack extends upwards through the brickwork and into the exposed earth. A further crack is visible to the left, running through the earth, but this is not visible within the building. The wall was built in a number of stages and has also been subjected to numerous repairs and alterations. The base of the wall was built around 1380 and extends the full distance across the front of the building. A second level was built sometime before 1550 and is fronted entirely with brick, although there appears to be a step just to the left of the ivy. A third building phase resulted in brick quoins extending the full height, with a rammed earth wall in between. This final stage actually extended one storey higher than at present and was removed during the building renovation in 1796 (Gerrard 2003).

The bottom of the north wall is leaning forward slightly when compared to the adjacent building in

Figure 6. View of major crack in the NE wall.

which was constructed in 1960 which can be assumed to be vertical. It is assumed that the next stage of building commenced onto an already leaning wall, and that the top sections of the wall are indeed vertical. There is however the possibility that the top of the north wall is falling forward, away from the building as it does not appear tied to the other walls at the top. It is assumed that originally the top storey tied the north wall into the structure, but following the removal of the top storey, the north wall is now unsupported.

The top storey was removed in order to prevent major structural collapse (Gerrard 2003). This would indicate that the cracking in the east wall were already present. What is not known is if the cracking has been stopped or dramatically reduced since 1796, is the

The reason for the initial crack is difficult to pinpoint, but one reason could be settlement of the made ground on which the wall is based. The land is sloping gently down to the north, with a made stone base upon which the rammed earth wall is built. A stream has been running across the north of the site for at least 1000 years, and while this is not very large, it is conceivable that this stream may have caused erosion, flooding or other activity leading to subsidence of the ground immediately under the tower. As the ground is already sloping, it is conceivable that the original builders made the level up in order to build the first level of the wall, which acted as a one storey building, and backs onto solid rock. After a number of years this wall was built up to three storeys, then again built up to 5 storeys. From the change in angle, it can be seen that the leaning forward of the wall occurred before 1380 and following this around 1550 the remainder of the wall was built.

The best method to prevent the cracks propagating is to pull the two surfaces closer together, but this must be

done in such a way that no further harmful stresses are developed. At present there is little published material on the structural stabilisation of rammed earth structures, although much has been published on new build, and there are many specific examples of restoration work. The present solution involves the bolting of steel I beams to the transverse roof timbers, which are then tensioned against H shaped bars fixed against the outside of the building. This solution, while appearing to work, is not ideal, in that the whole overturning force of the north wall is taken on the timber beams, and that there is a large visual impact on the front of the building.

The authors considered a number of solutions. Grouted reinforcement bars could be inserted into the north wall and travel through into the east wall. These bars could either be anchored externally in a similar fashion to the H bars present at the moment, or may be able to provide enough resistance though application of grout.

A tested retrofitting technique is the application of nylon strapping to provide tensile support across the crack. This strapping would have to be bolted into place, and again the effect of bolting structural elements into existing walls has never been thoroughly investigated, but would provide an easy and cheap solution to cracking in rammed earth walls.
